Title: **QUALITY AUDIT**

Road Safety Audit, Access Audit, Cycle Audit and Walking

Carlisle Residential Development, Kimmage Road West,

Kimmage, Dublin 12.

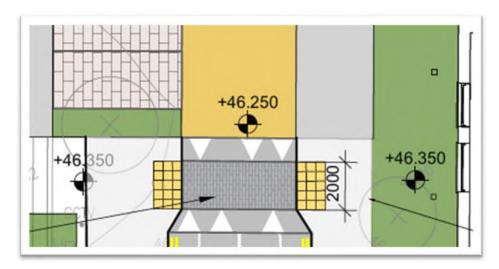
Drawing CST-BMD-00-ZZ-DR-C-1017 PL Rev 5, Entrance to Residential Area.

Drivers entering the residential area will be on a different surface type that will have pedestrians, cyclists and those getting into and out of their vehicles. Without adequate warning drivers may travel at excessive speed increasing the risk of collisions with those vulnerable road users.

It is recommended that a shared use type sign, similar to F404 of the Traffic Signs Manual be provided at the entry to this area.

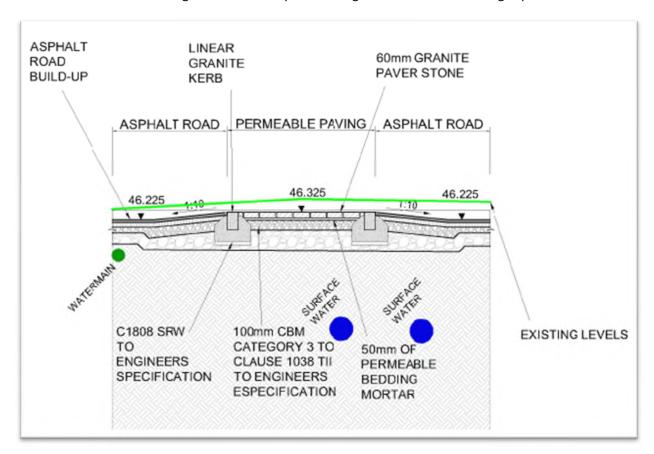
Drawing CST-BMD-00-ZZ-DR-C-1025 PL Rev 1, Section F-F, raised pedestrian crossing.

There is a risk that the proposed 1:10 slopes of the raised crossing may be too severe for a 100mm high ramp leading to injury for vehicle occupants. It is also unclear if the permeable bedding will be sufficient to withstand vehicular loading and lead to the pavers being disturbed and becoming trip hazards.

It is recommended that suitable gradients be used and that the surface be designed to withstand vehicular loading.
